INDOOR AIR QUALITY ASSESSMENT

**Mount Everett High School
South Berkshire Regional School District
491 Berkshire School Road
Sheffield, Massachusetts**

Prepared by:
Massachusetts Department of Public Health
Bureau of Environmental Health Assessment
August 2002

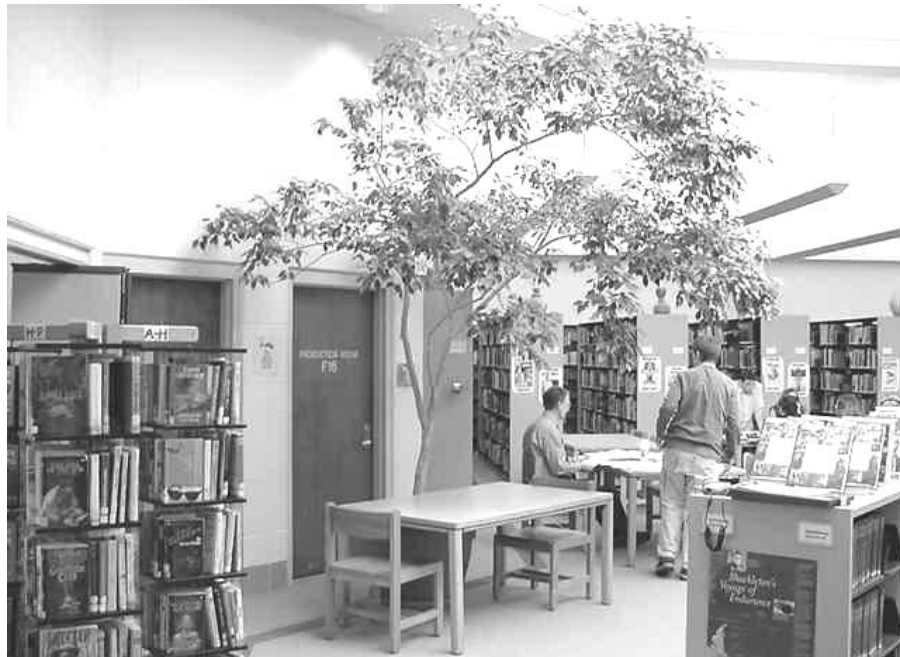
Picture 2

The library had a large potted plant located on wall-to-wall carpeting (see Picture 2). Plant soil and drip pans can serve as sources of mold growth. Plants should have drip pans and over-watering of plants should be avoided. Drip pans should be inspected periodically for mold growth. Plants should also be located away from univents to prevent the aerosolization of mold, dirt and pollen.

Potted Plant On Library Carpet

10. Remove plants from carpeted floor in library. Examine carpet underneath planter for mold growth. If moldy, remove/replace contaminated section of carpet. Disinfect non-porous areas with an appropriate antimicrobial where necessary.

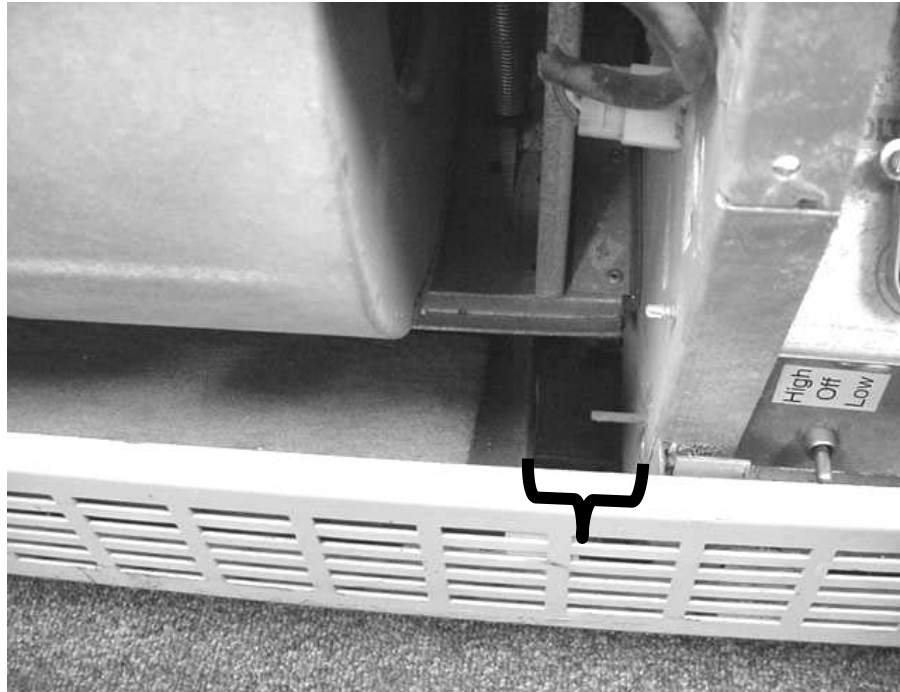
Picture 3

Several other conditions that can potentially affect indoor air quality were also identified. Univents were spot checked throughout the school complex. In some cases, the univent filter was removed and found to be smaller than the filter rack (see Picture 3). Filters should be of sufficient size to fit flush into the entire rack. If filters do not fit flush with filter racks, air drawn into the univent will bypass filters and pass through spaces between filters and racks. This can result in dust, dirt and other debris being distributed by the ventilation system.

Undersized Filter in Univent

3. Ensure that filters in univents are of proper size. Examine the filters in the univents and air handling units (AHUs) in common areas (e.g. auditorium and gym) and change these filters on a regular basis. Consider increasing the dust spot efficiency of filters to increase the removal of particulates from the environment.

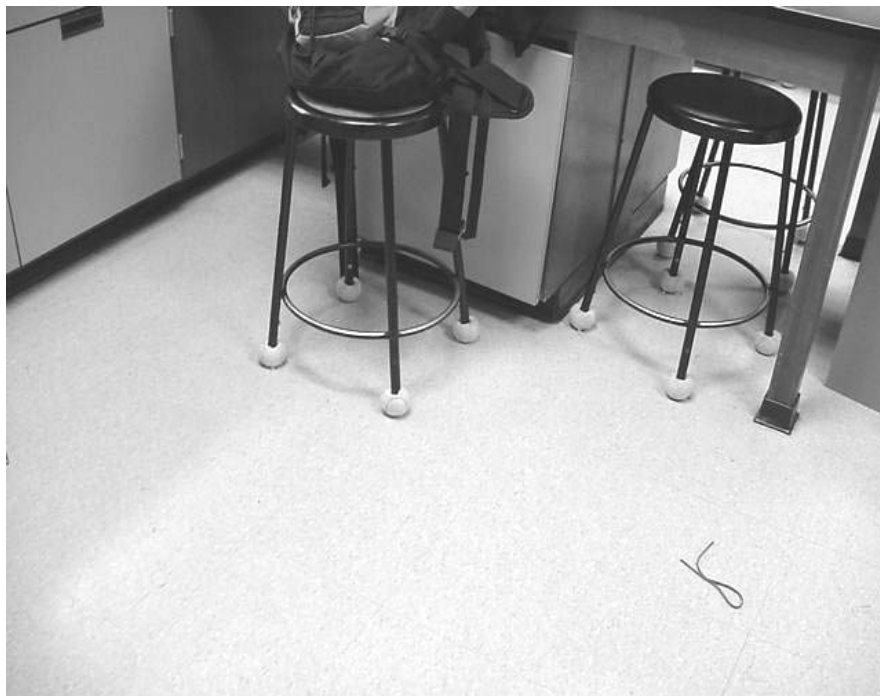
Picture 4

In an effort to reduce noise from sliding chairs, tennis balls are sliced open and placed on stool legs (see Picture 4). Tennis balls are made of a number of materials that can be a source of respiratory irritants. Constant wearing of tennis balls can produce fibers and off-gassing volatile organic compounds (VOCs). Tennis balls are made with a natural rubber latex bladder, which becomes abraded when used as a chair leg pad. Use of tennis balls in this manner may introduce latex dust into the school environment. Some individuals are highly allergic to latex (e.g., spina bifida patients) (SBAA, 2001). It is recommended that the use of materials containing latex be limited in buildings to reduce the likelihood of symptoms in sensitive individuals (NIOSH, 1997). A question and answer sheet concerning latex allergy is attached as [Appendix II](#) (NIOSH, 1998).

Tennis Balls On Stool Legs

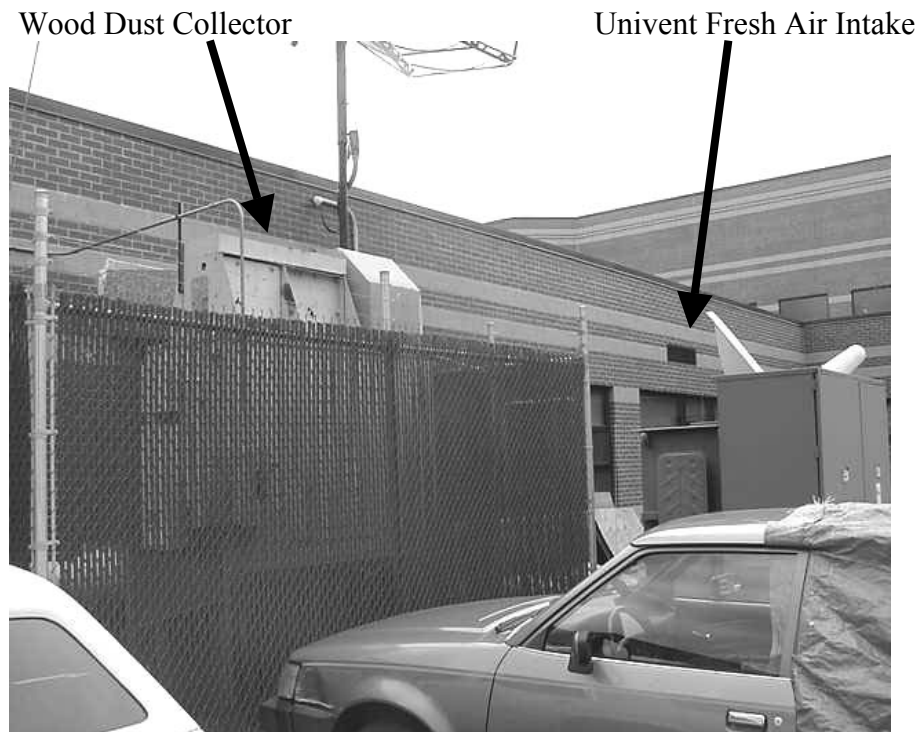
Picture 5

A noticeable odor of wood dust was detected in the hallway outside the door to the wood shop. Spaces were noted at the bottom and between hallway doors, which can allow for saw dust and other pollutants to migrate from the shop to the hallway. The shop has a wood dust collection system. The dust collector is located outdoors, in close proximity to the fresh air intake for the univent in room E1 (see Picture 5). As air is vented from this collector fine wood dust may be entrained by this univent fresh air intake and introduced to occupied space.

Wood Dust Collector in Close Proximity to Room E-1 Univent Fresh Air Intake

6. Install weather stripping around the door frame and door sweeps at the bottom of and between wood shop hallway doors to serve as a barrier.
7. Examine the feasibility of installing a hood on top of the wood dust collector to direct exhaust air away from the univent fresh air intake.

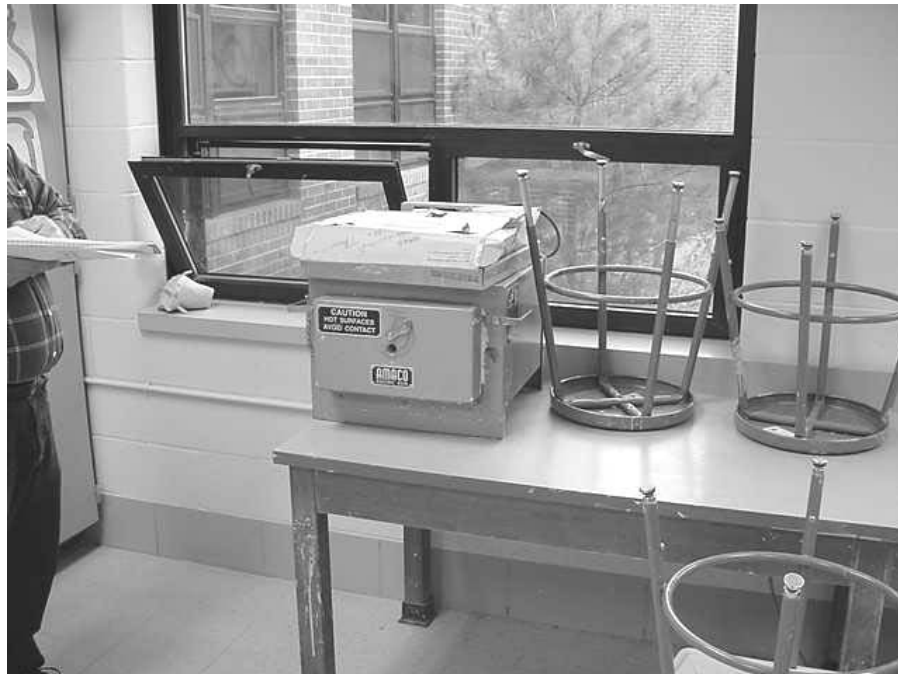
Picture 6

Room D1 contained a jewelry kiln on a counter (see Picture 6). While a general exhaust system exists in these rooms, no dedicated local exhaust ventilation was provided for this machinery. Kilns can produce metal fumes, dust, smoke and odors, which should be vented outdoors. Of note is the cleanliness of the pottery classroom. Over the course of numerous high school inspections, few pottery classrooms have been found as free of accumulated clay dust as in this room.

Jewelry Kiln On A Counter

12. Move jewelry kiln into kiln room to provide exhaust ventilation.
13. Pour water into eye wash drains on a regular basis to keep traps wet.
14. Have a chemical inventory done in all storage areas and classrooms. Discard hazardous materials or empty containers of hazardous materials in a manner consistent with environmental statutes and regulations. Follow proper procedures for storing and securing hazardous materials. Obtain Material Safety Data Sheets (MSDS') for chemicals from manufacturers or suppliers.

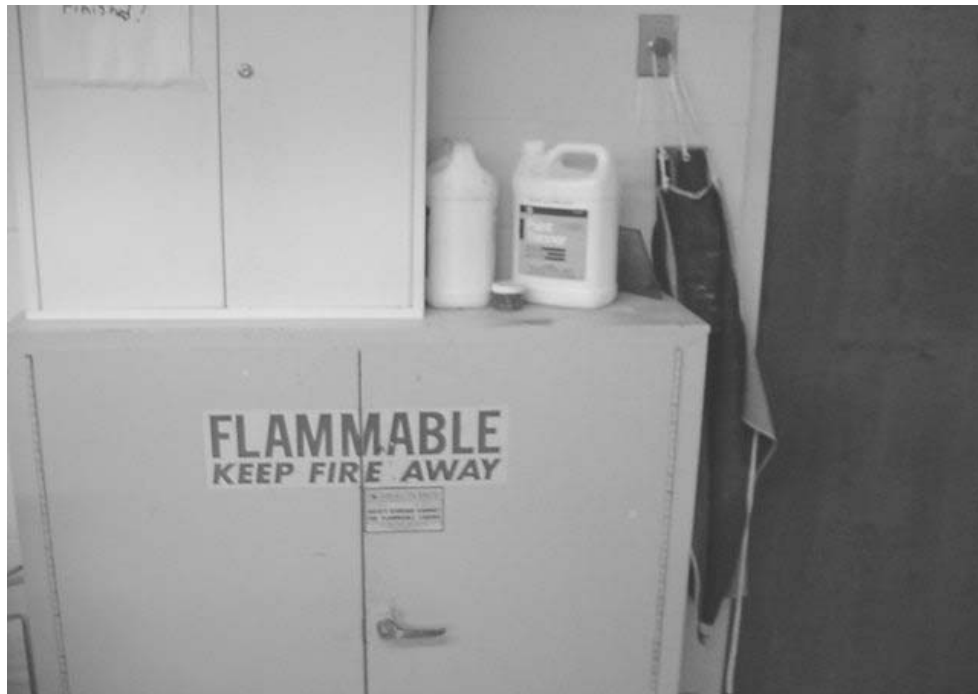
Picture 7

A container of flammable material was stored outside the flameproof cabinet in the wood shop (see Picture 7). Flammable materials should be stored in a cabinet that meets the requirements of the National Fire Prevention Association (NFPA) (NFPA, 1996).

Paint Thinner Stored On Top Of Flameproof Cabinet

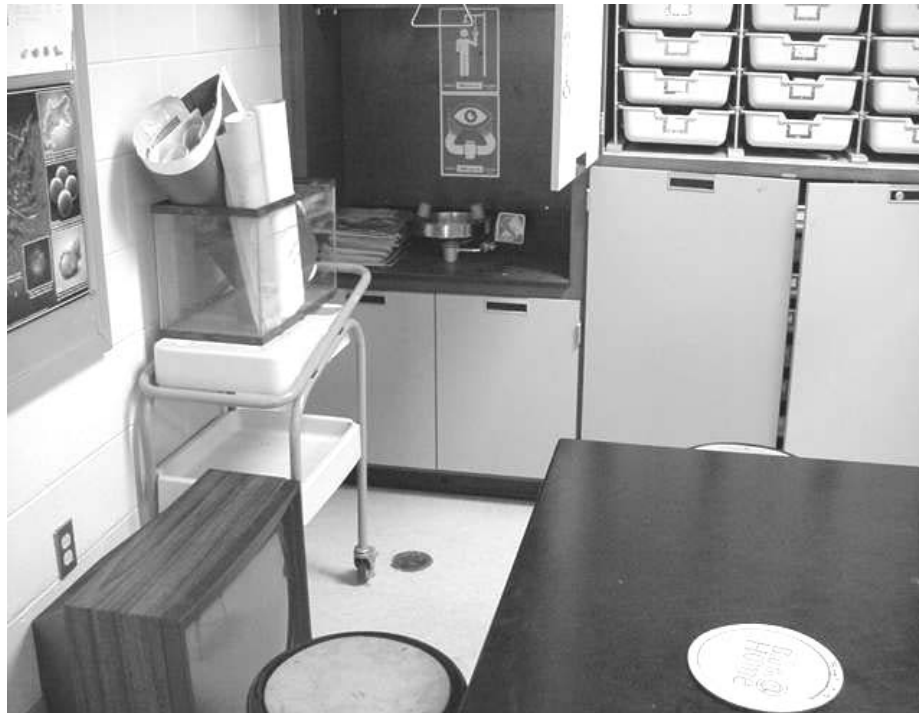
Picture 8

Science classrooms are equipped with bubbler type eyewash stations (see Picture 8). Each of these eye wash stations is equipped with a drain trap. Without periodic water poured into the drain, the traps on the eye wash station may dry out, which can result in sewer gas migration into science classrooms. Sewer gas can contain hydrogen sulfide, which is an irritant to eyes, nose and the respiratory system.

Eyewash Station
